## **Reference 13**

**Falcon Refinery  
TXD 086 278 058**

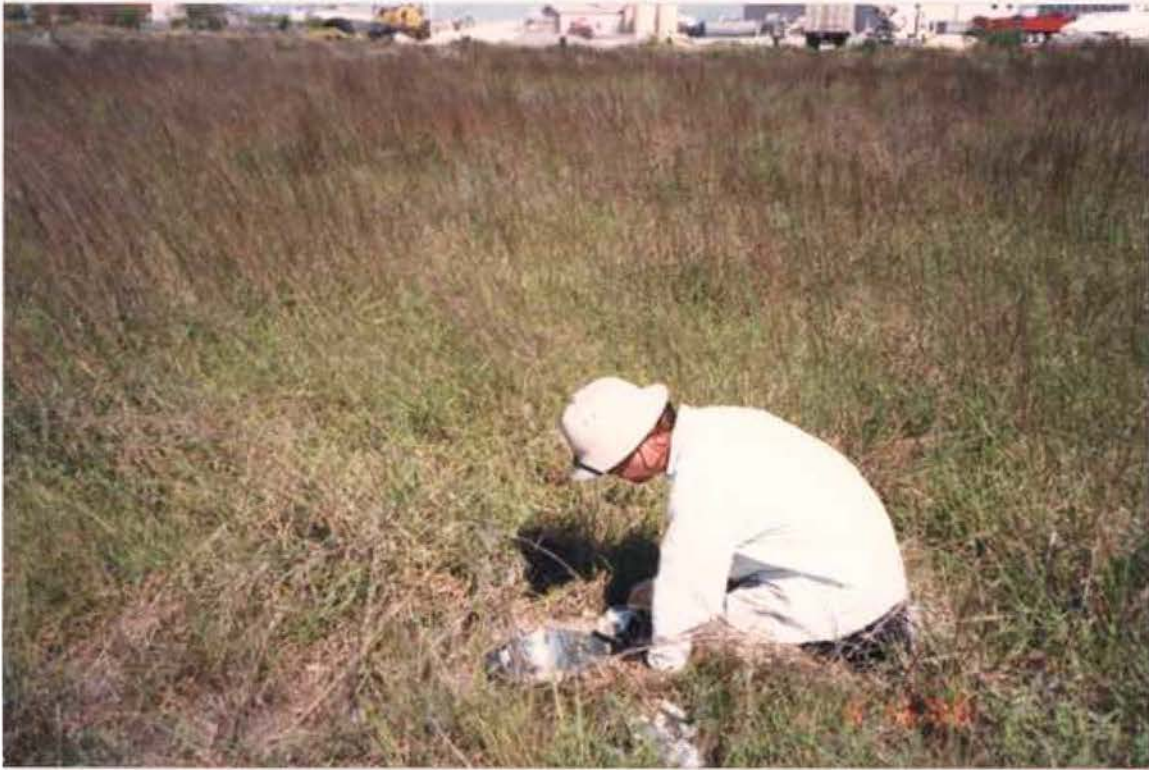
**Roll #2 Photo 4 - 5/16/2000 Taken by: A. Seils. Sampler: M. Cedilote. Collection of Background Sample SE-28 off of FM 2725. Direction: Northeast.**

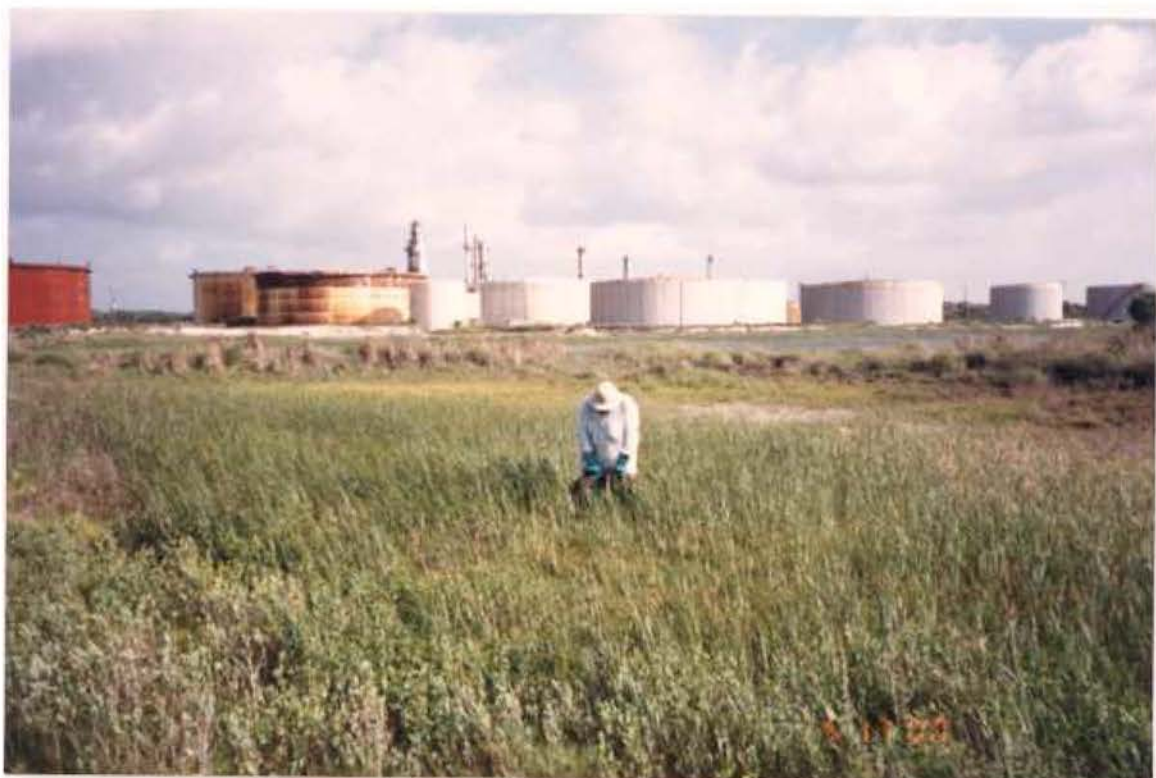
Roll #2 Photo 5 - 5/16/2000 Taken by: A. Seils. Sampler: M. Cedilote. Collection of Background Sample SO-21 off of FM 2725. Direction: South.

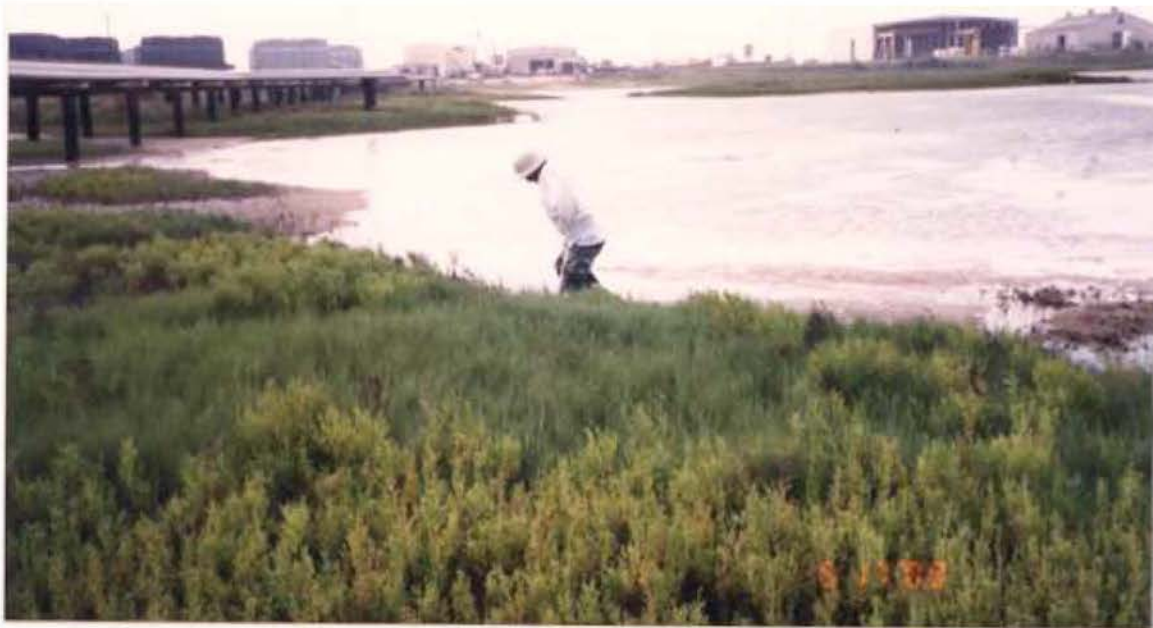
Roll #2 Photo 6 - 5/16/2000 Taken by: A. Seils. Sampler: M. Cedilote. Collection of Sample SE-26. Direction: Northwest.

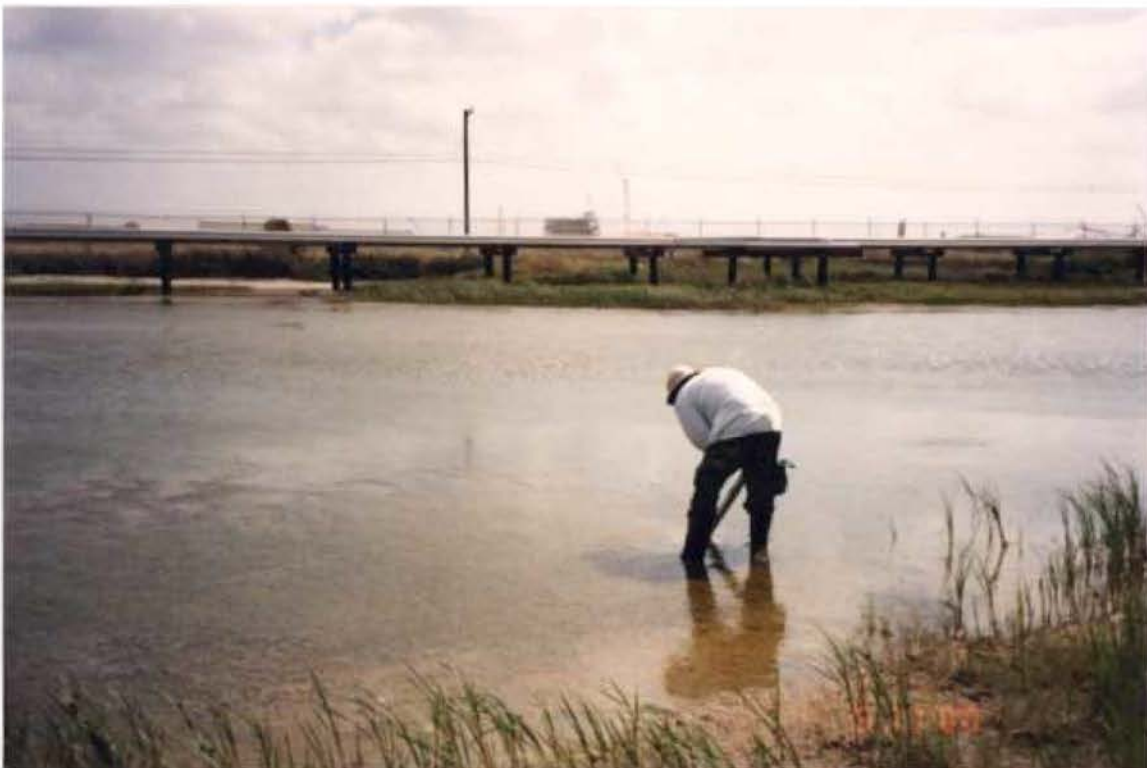
Roll #2 Photo 7 - 5/17/2000 Taken by: A. Seils. Sampler: M. Cedilote. Collection of Sample SE-20 along drainage pathway from the API separator and surface impoundment. Direction: Northeast.

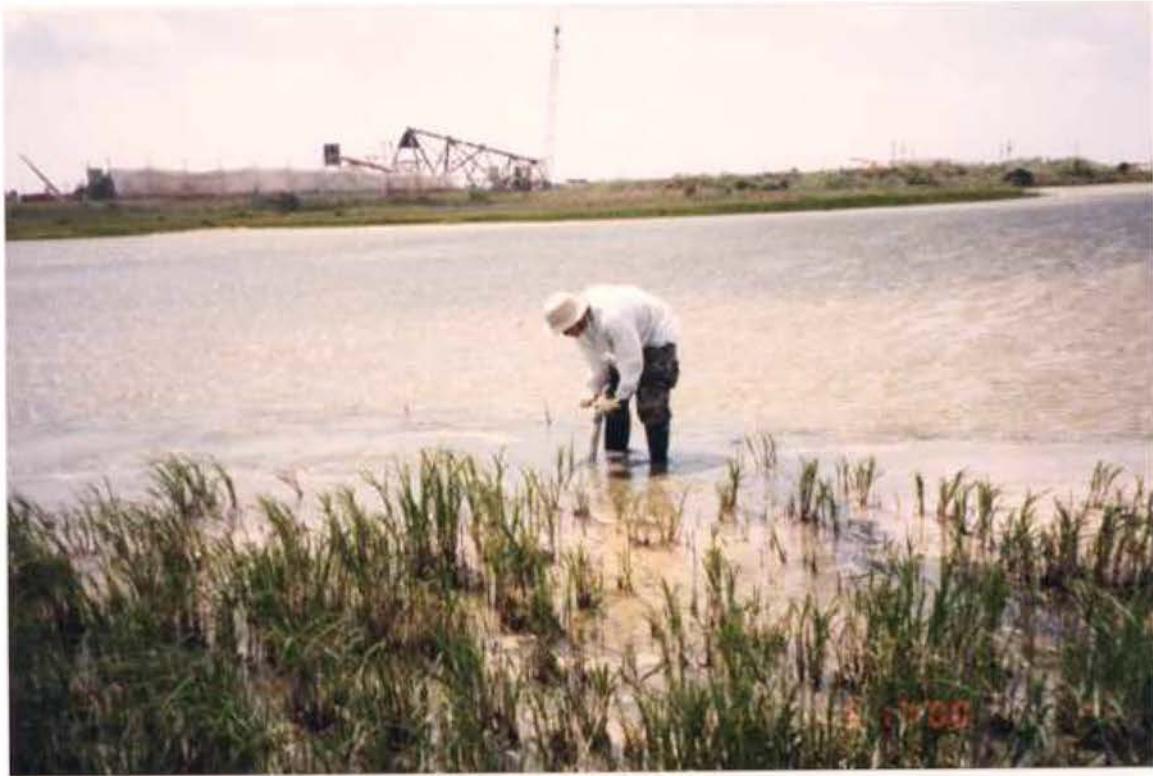
Roll #2 Photo 8 - 5/17/2000 Taken by: A. Seils. Sampler: M. Cedilote. Collection of Sample SE-21 in HRS defined wetland area. Direction: Northeast.

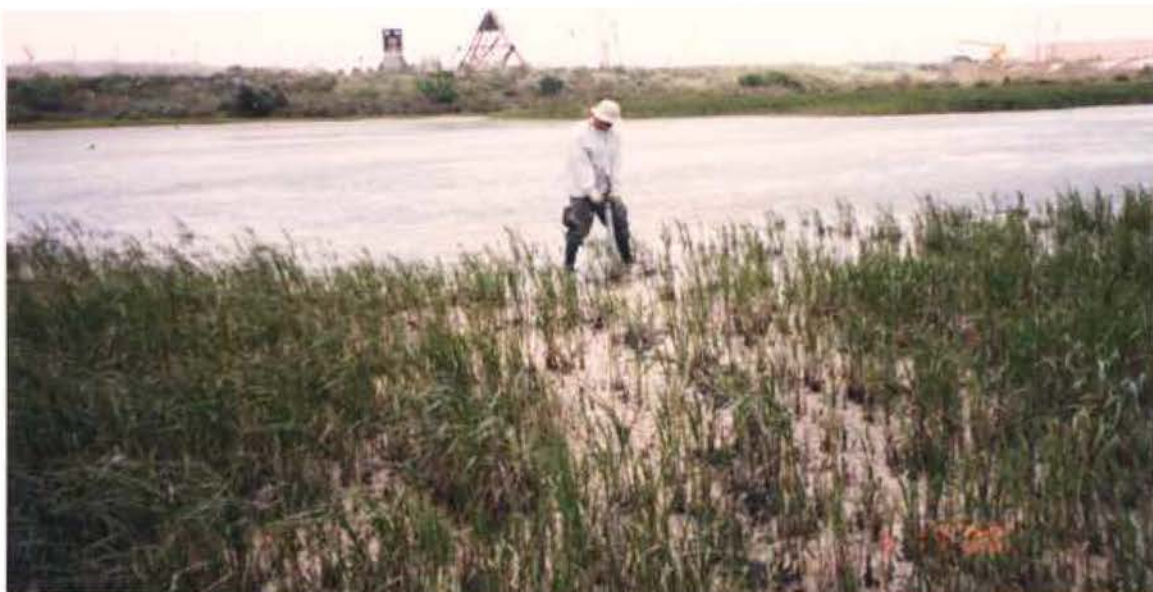
Roll #2 Photo 9 - 5/17/2000 Taken by: A. Seils. Sampler: M. Cedilote. Collection of Sample SE-22 and SE-23 in HRS defined wetland area. Direction: Southeast.

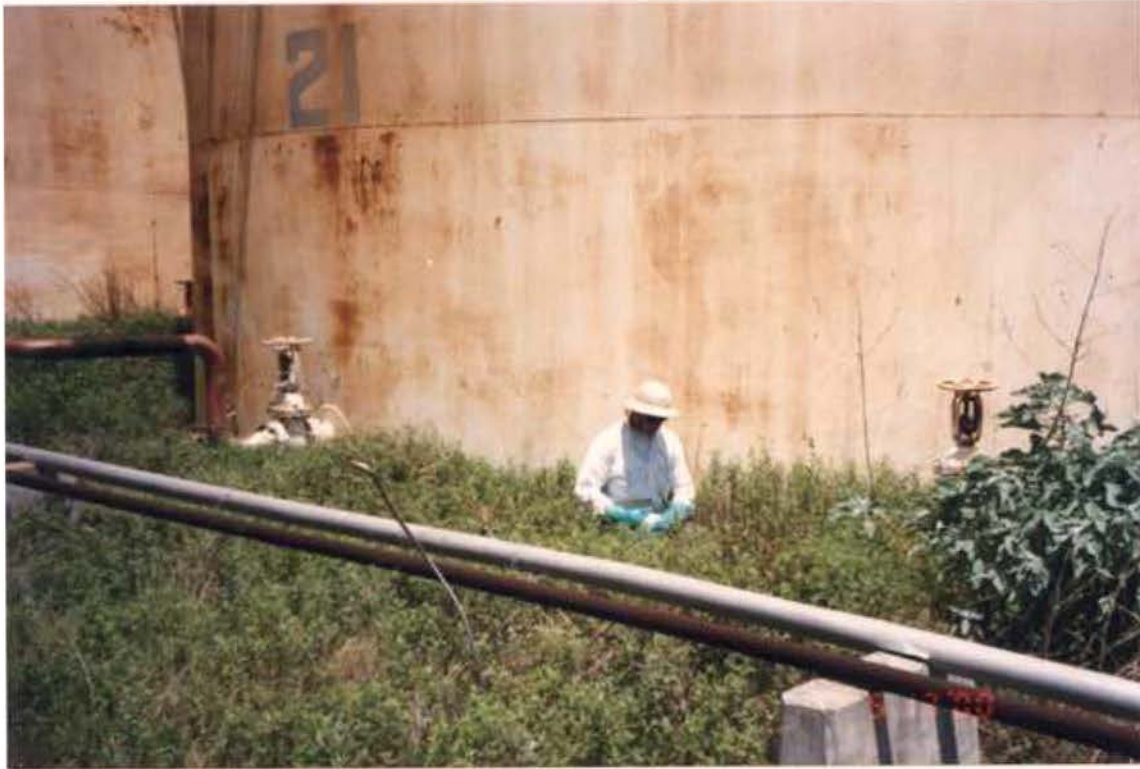
Roll #2 Photo 10 - 5/17/2000 Taken by: A. Seils. Sampler: M. Cedilote. Collection of Sample SE-24 in HRS defined wetland area. Direction: Northwest.

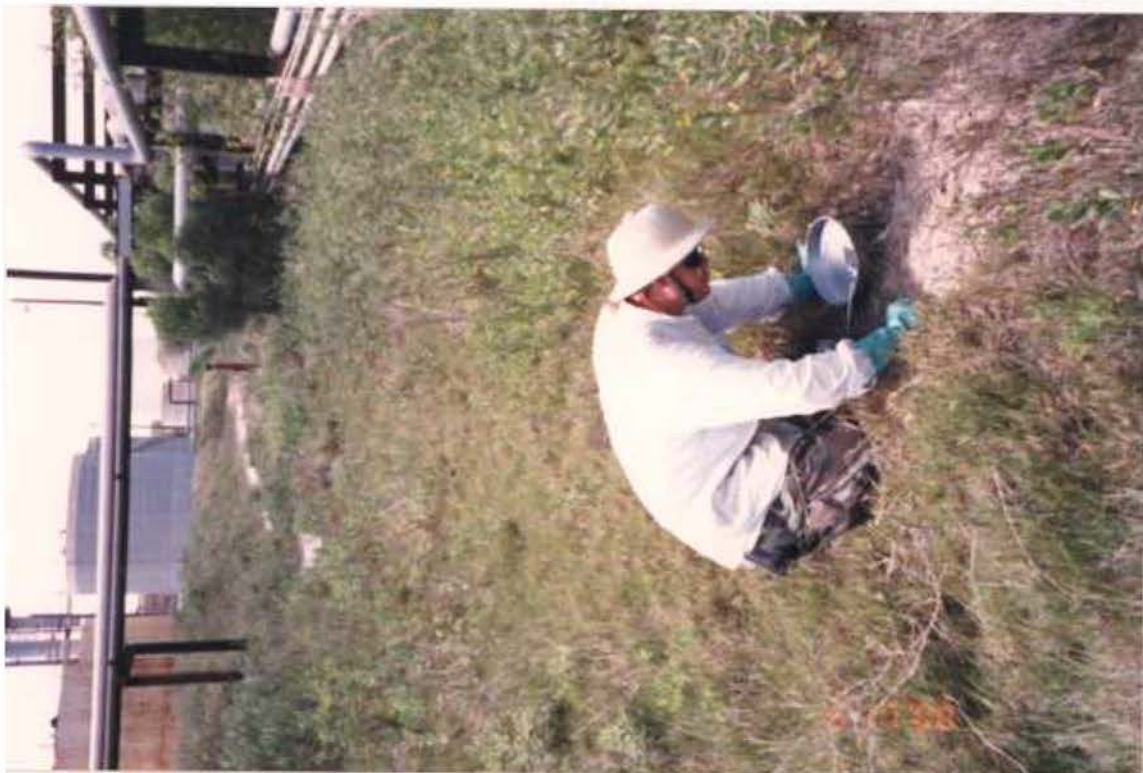
Roll #2 Photo 13 - 5/17/2000 Taken by: A. Seils. Sampler: M. Cedilote. Collection of Sample SO-12 near Tank 21. Direction: Northeast.

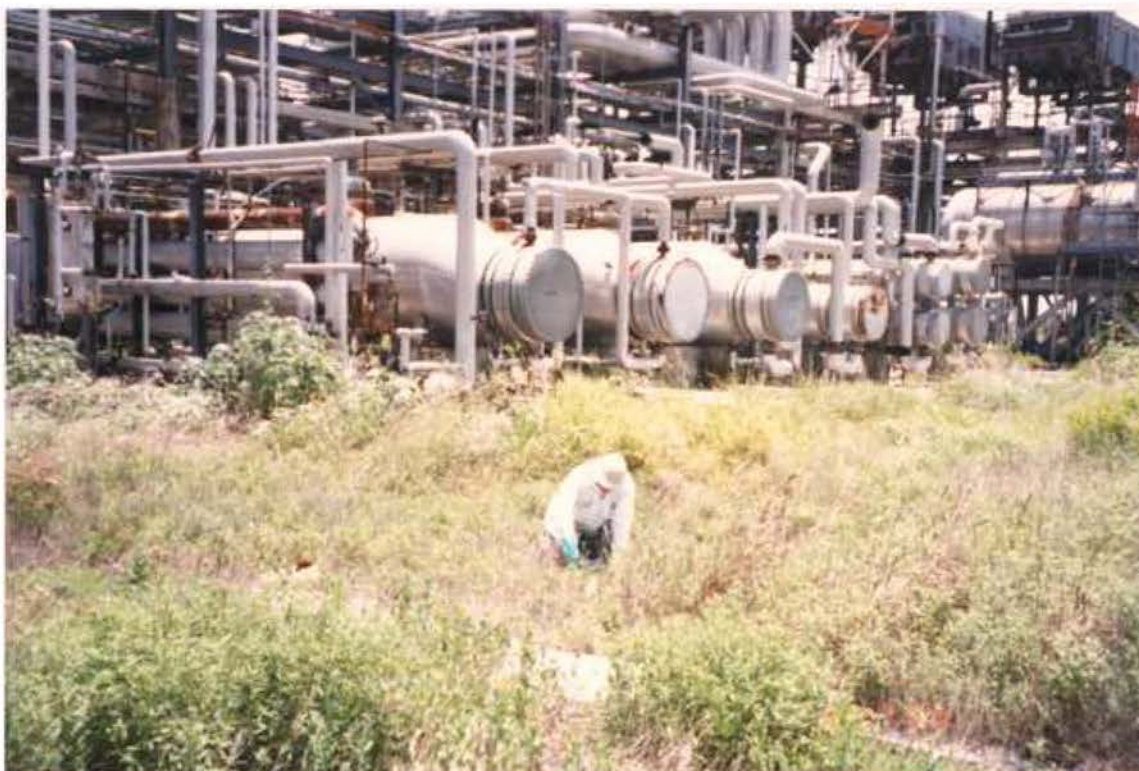
Roll #2 Photo 11 - 5/17/2000 Taken by: A. Seils. Sampler: M. Cedilote. Collection of Sample SO-10 near the process area. Direction: Northeast.

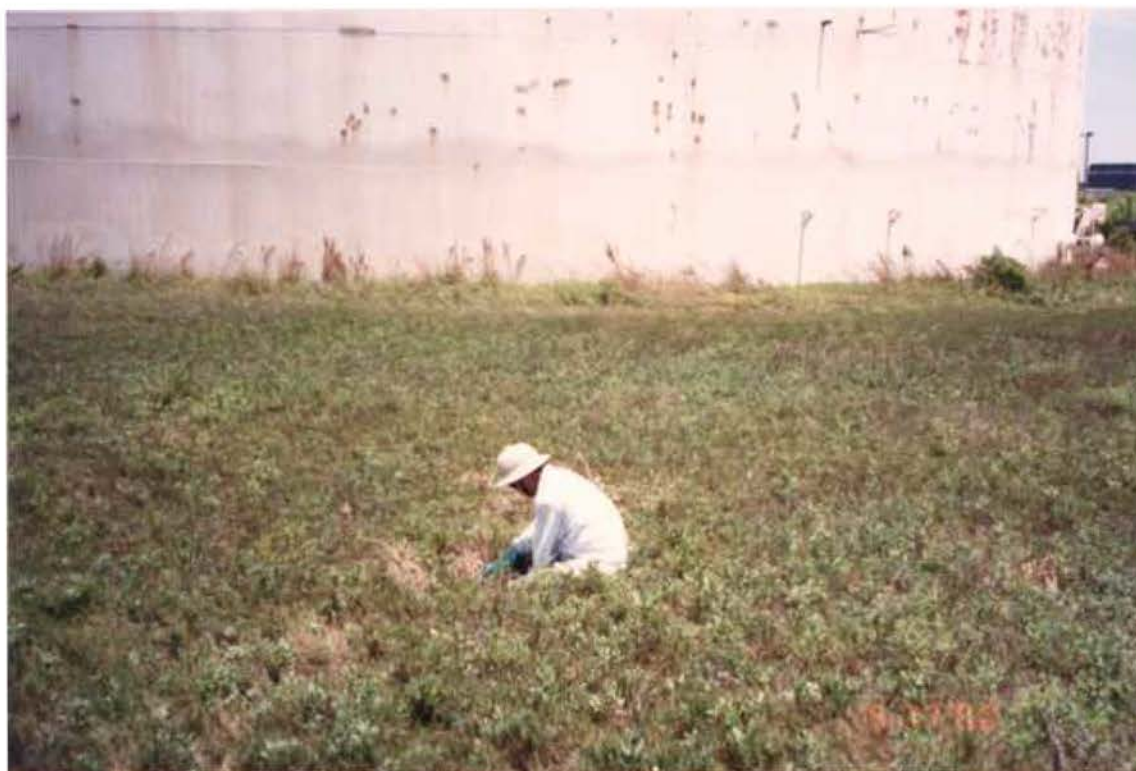
Roll #2 Photo 12 - 5/17/2000 Taken by: A. Seils. Sampler: M. Cedilote. Collection of Sample SO-11 near Tank 13. Direction: Northeast.

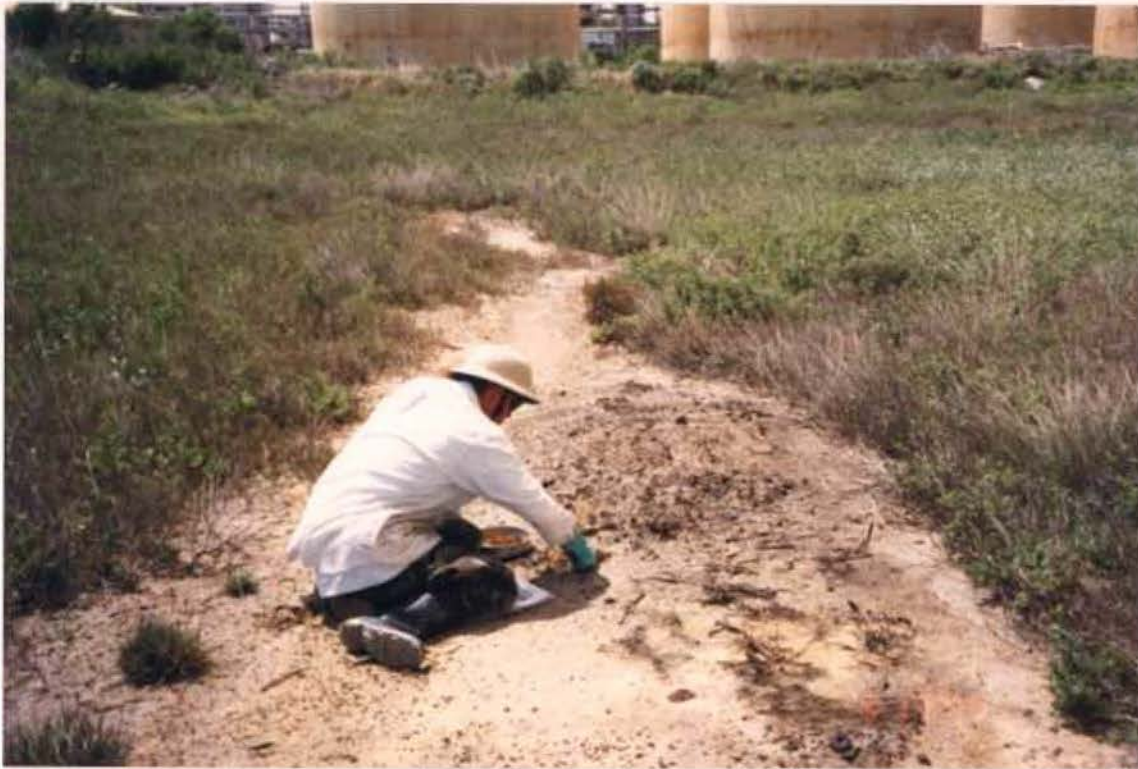
Roll #2 Photo 15 - 5/17/2000 Taken by: A. Seils. Sampler: M. Cedilote. Collection of Sample SO-33 near Tank 14. Direction: Northwest.

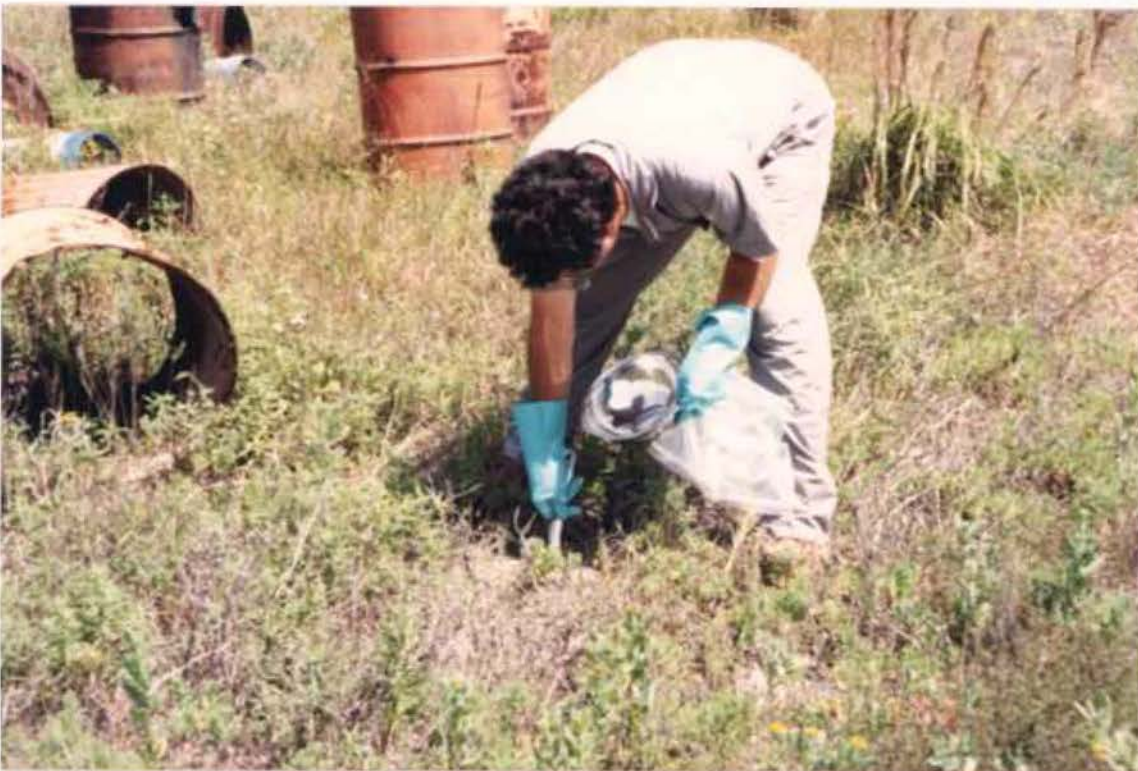
Roll #2 Photo 16 - 5/17/2000 Taken by: M.Cordell. Sampler: W. Newberry. Collection of Sample SO-19 near area of suspected leaking drums. Direction: East.

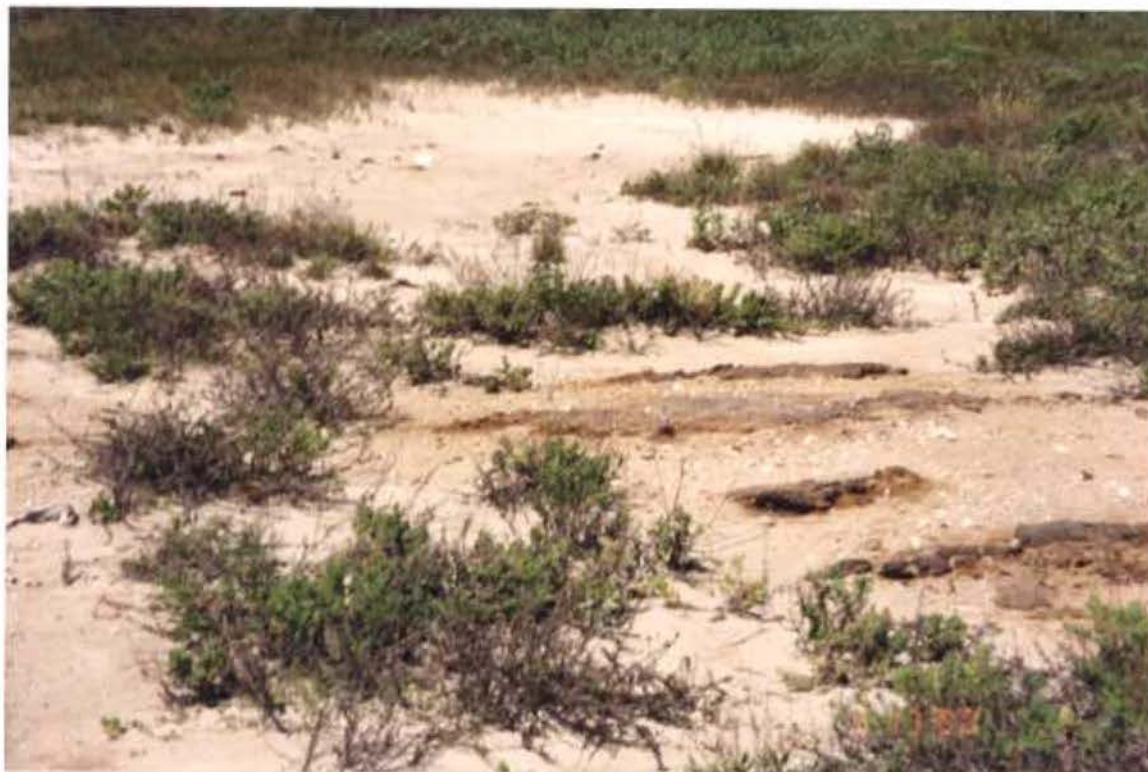
Roll #2 Photo 20 - 5/17/2000 Taken by: M.Cordell. Sampler: W. Newberry. Location of Sample SO-31 and SO-34. Direction: Northeast.

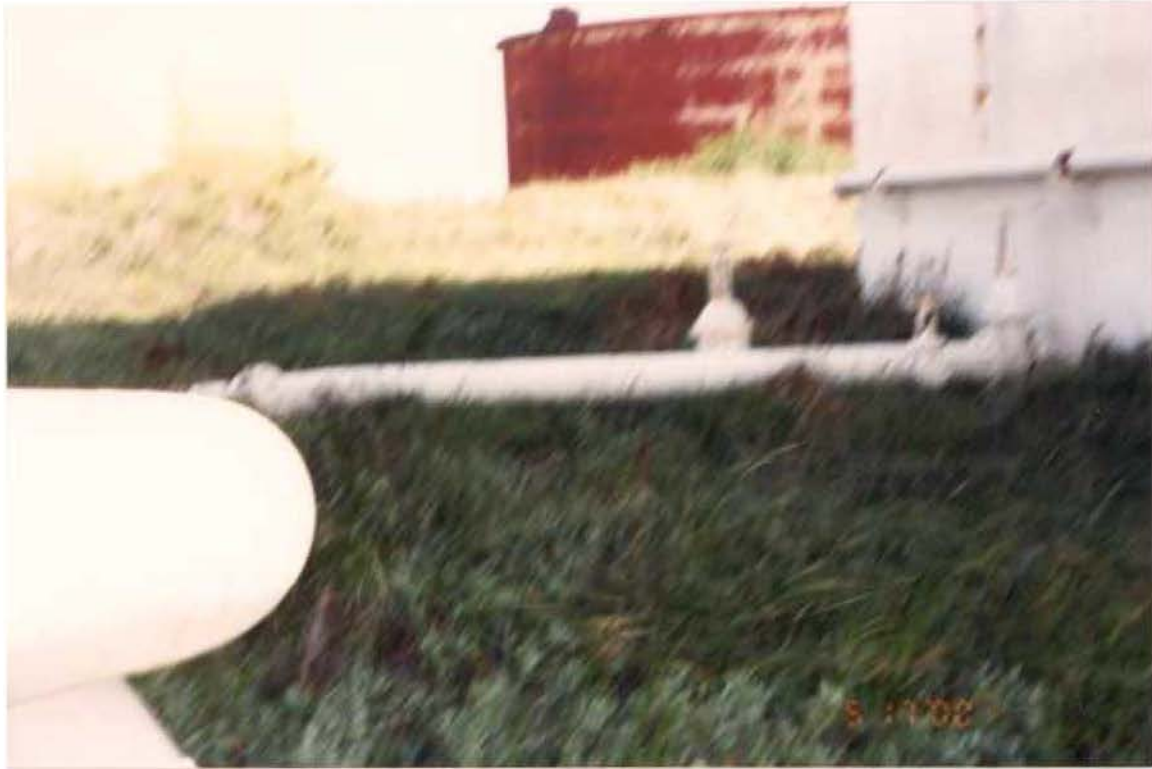
Roll #2 Photo 21 - 5/17/2000 Taken by: M.Cordell. Sampler: W. Newberry. Location of Sample SO-17.  
Direction: Southeast.

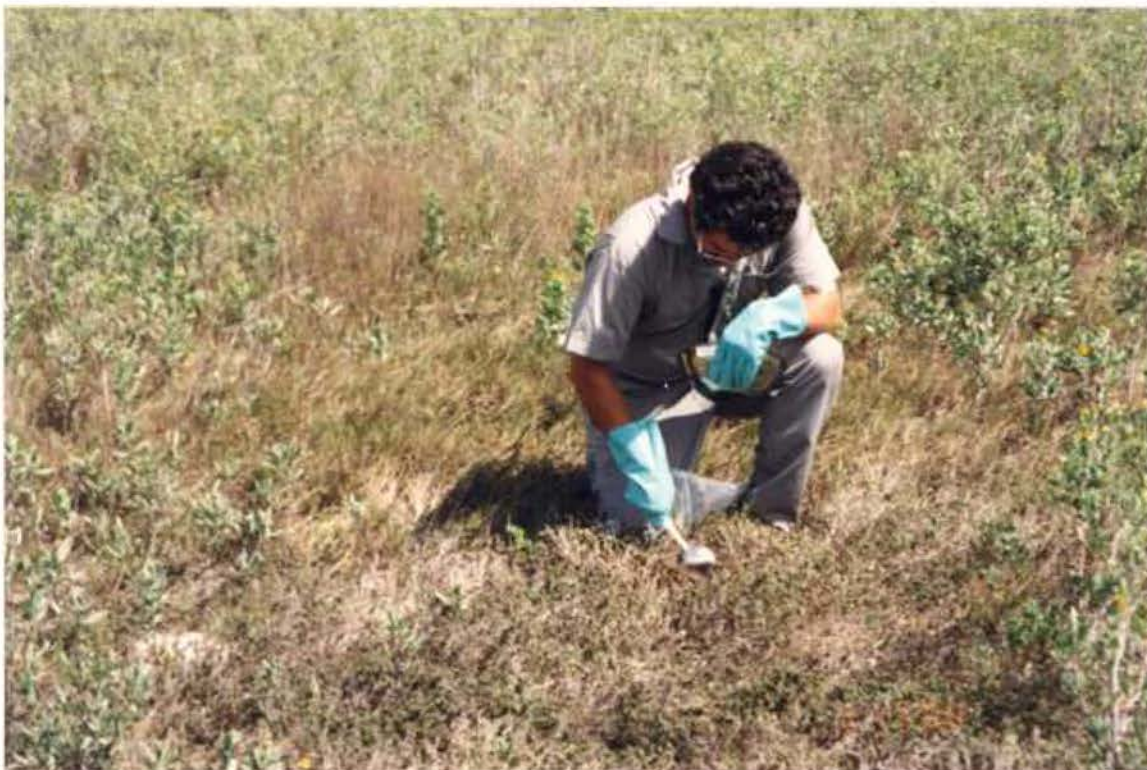
Roll #2 Photo 22 - 5/17/2000 Taken by: M.Cordell. Sampler: W. Newberry. Collection of Sample SO-26.  
Direction: East.

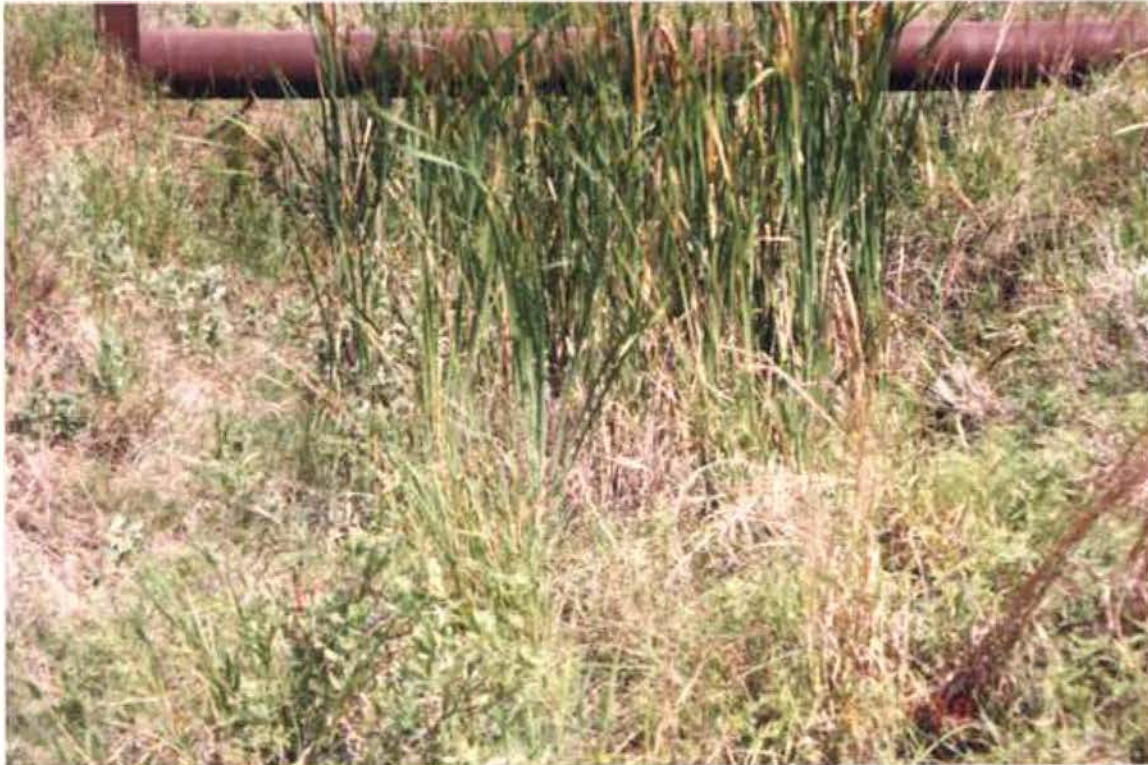
Roll #2 Photo 23 - 5/17/2000 Taken by: M.Cordell. Sampler: W. Newberry. Location of Sample SO-30.  
Direction: Southeast.

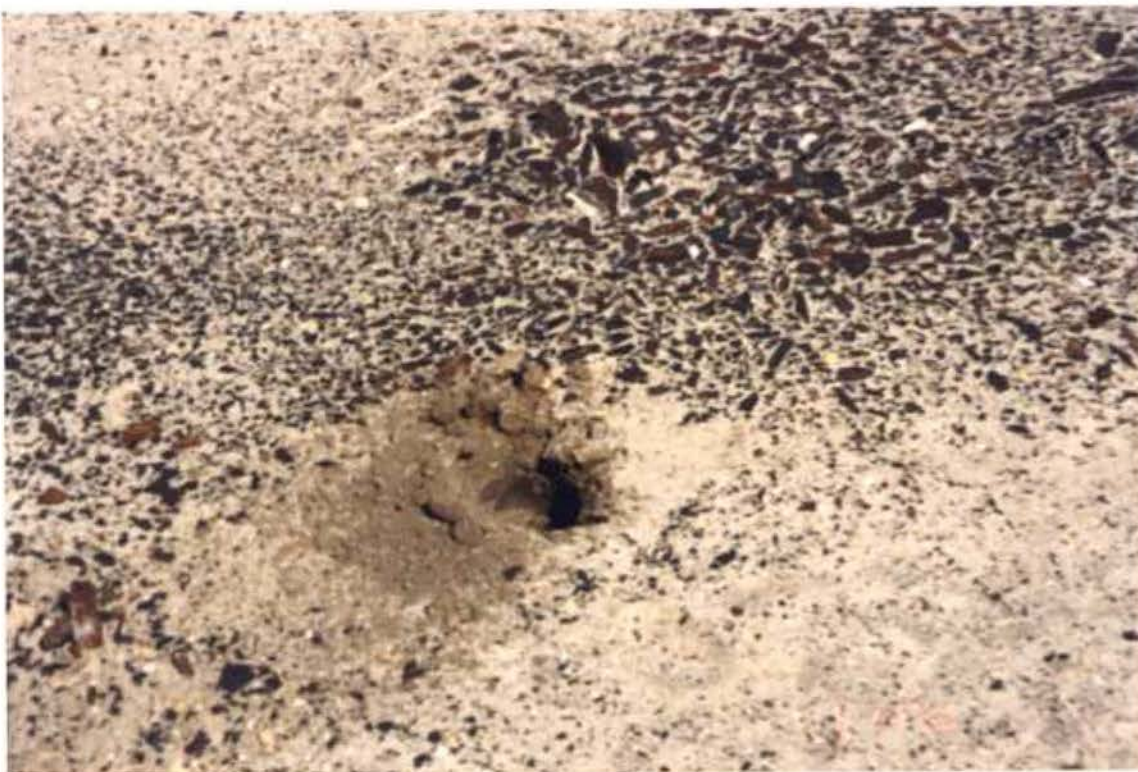
Roll #2 Photo 24 - 5/17/2000 Taken by: M.Cordell. Sampler: W. Newberry. Location of Sample SO-27.  
Direction: Southeast.

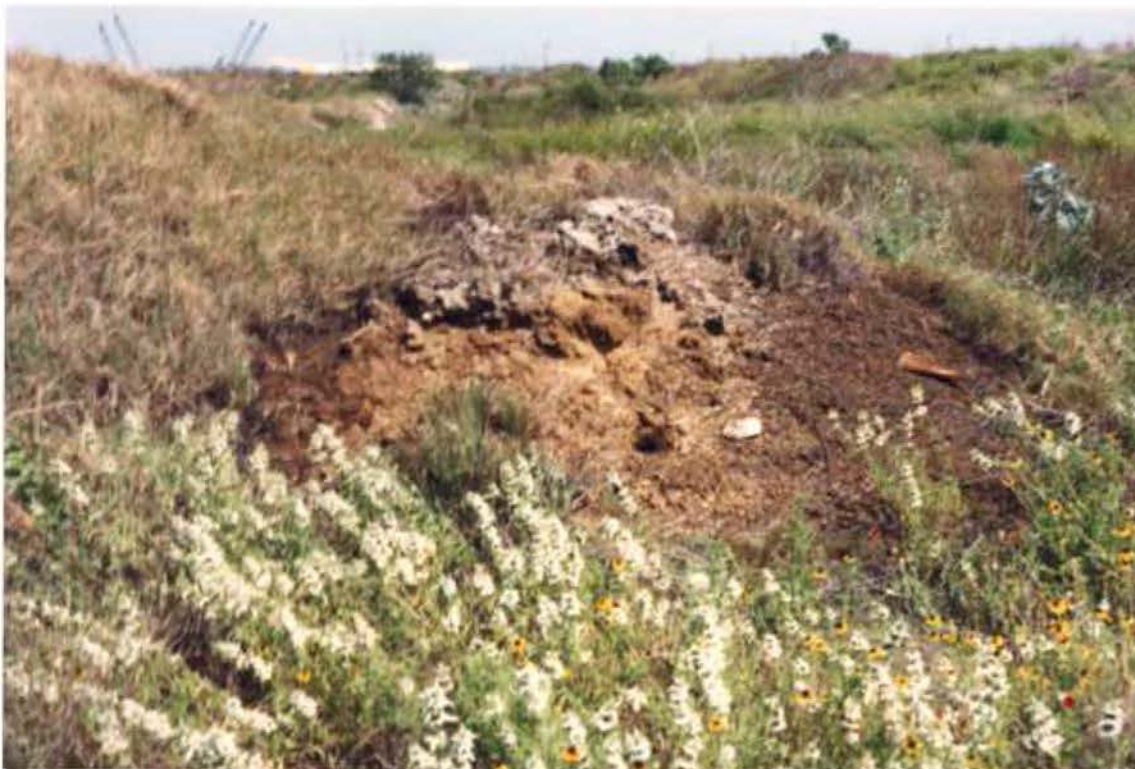
Roll #2 Photo 25 - 5/17/2000 Taken by: M.Cordell. Sampler: W. Newberry. Location of Sample SO-28.  
Direction: Southeast.

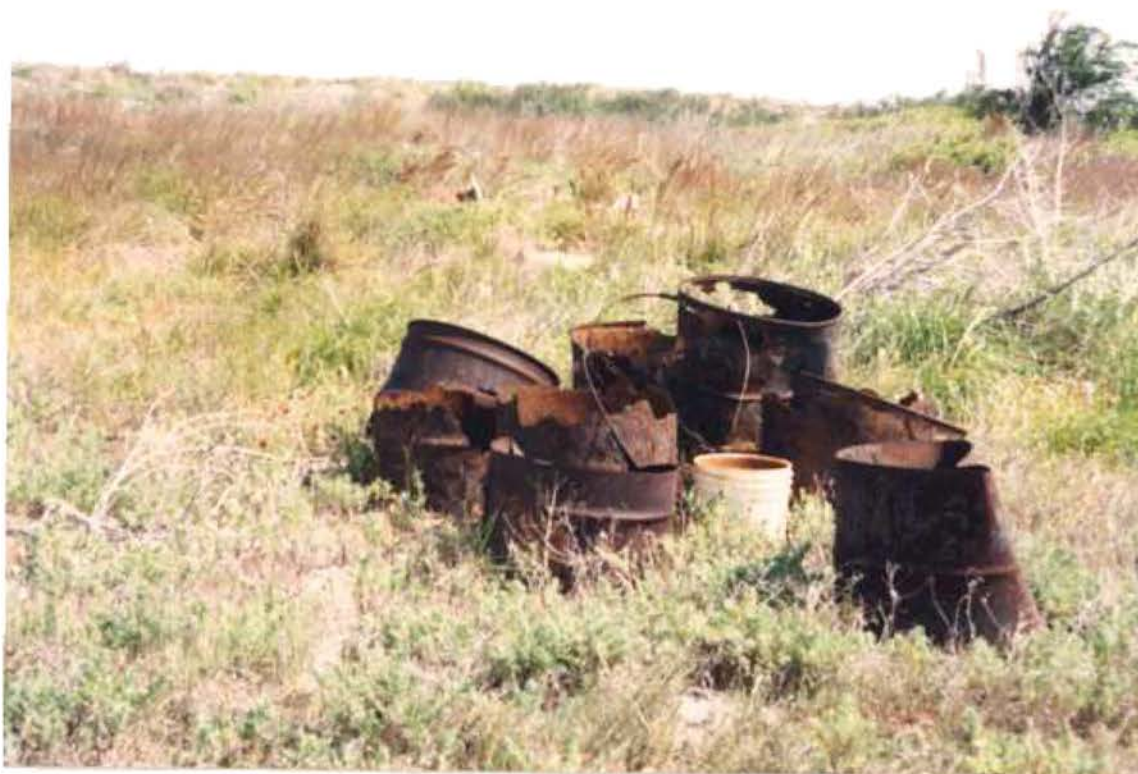
Roll #2 Photo 26 - 5/17/2000 Taken by: M.Cordell. Area of deteriorating drums, southwest of SO-28.  
Direction: South.

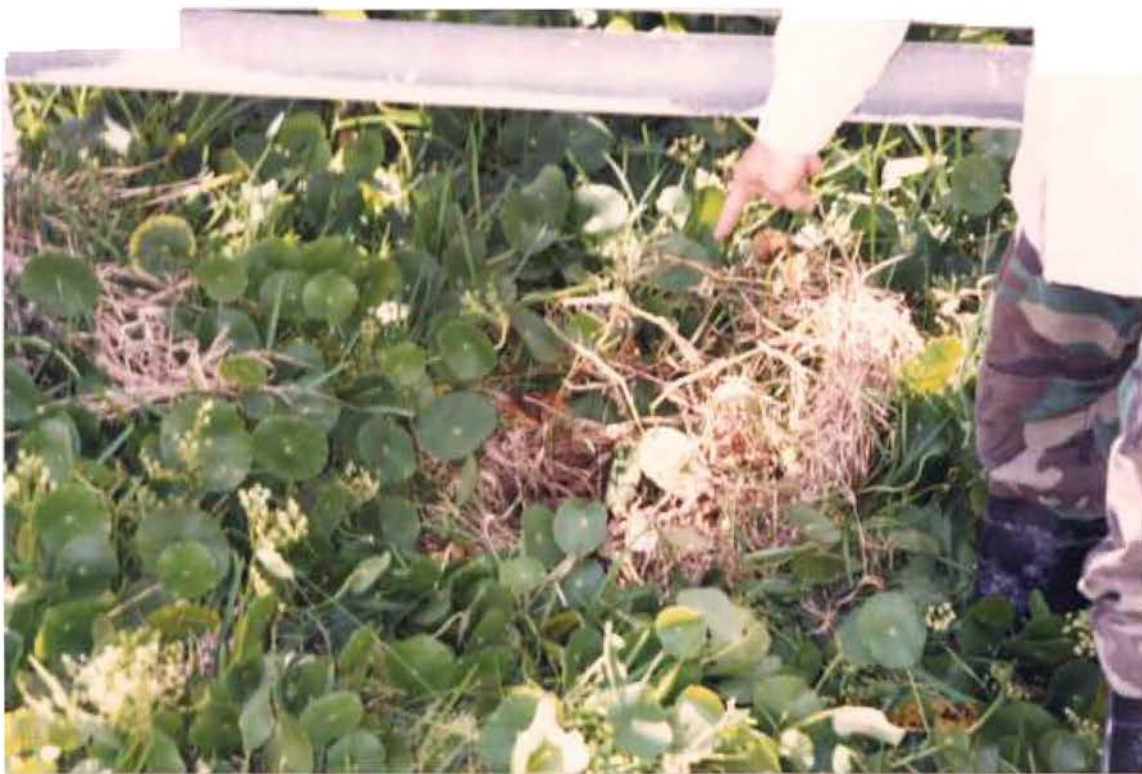
Roll #2 Photo 28 -5/18/2000 Taken by: M.Cordell. Sampler: M. Cedilote. Location of Sample SO-09. Direction: Southeast.

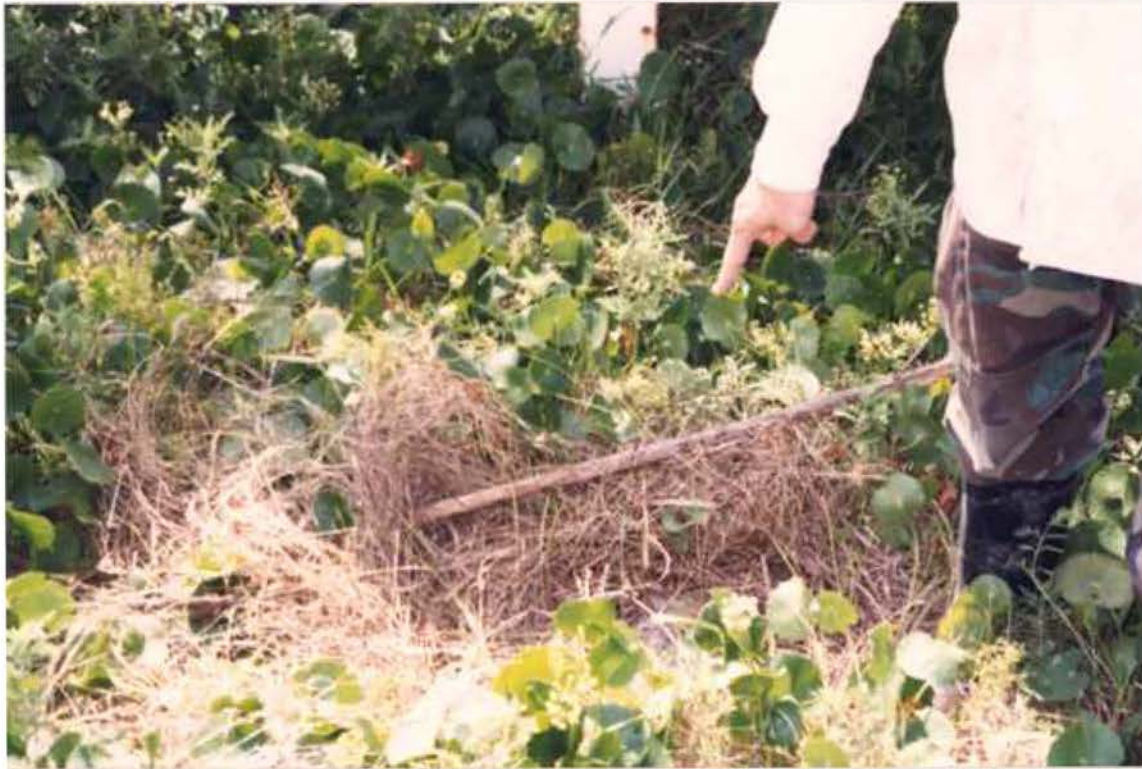
Roll #2 Photo 29 -5/18/2000 Taken by: M.Cordell. Sampler: M. Cedilote. Location of Sample SO-13. Direction: Southeast.

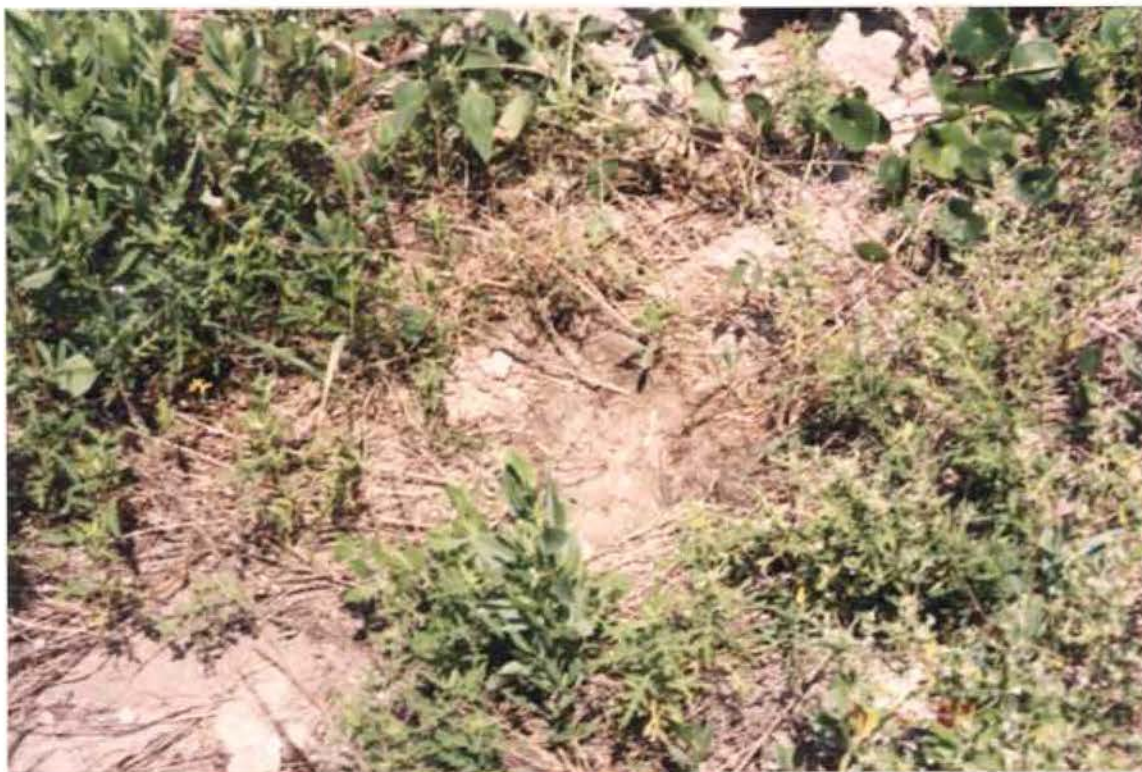
Roll #2 Photo 30 -5/18/2000 Taken by: M.Cordell. Sampler: M. Cedilote. Collection of Sample SO-07 and SO-08. Direction: Southwest.

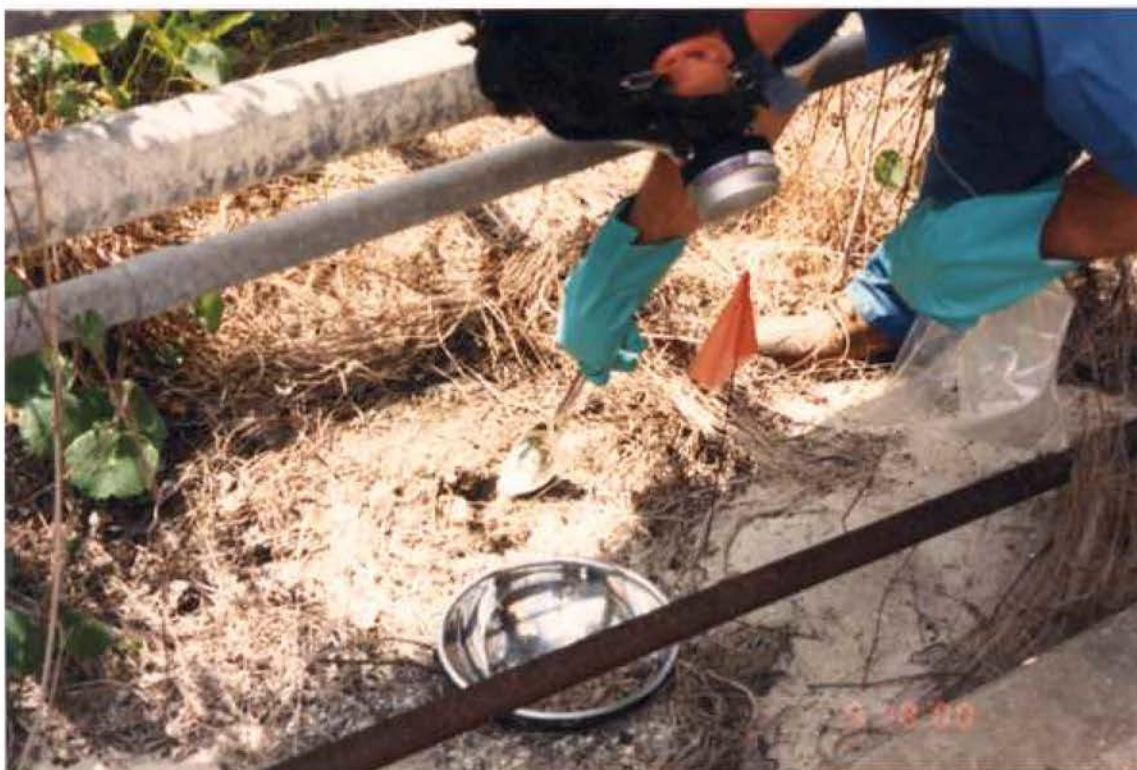
Roll #2 Photo 31 - 5/18/2000 Taken by: M.Cordell. Sampler: W. Newberry. Collection of Sample SO-02 and SO-04. Direction: Southwest.

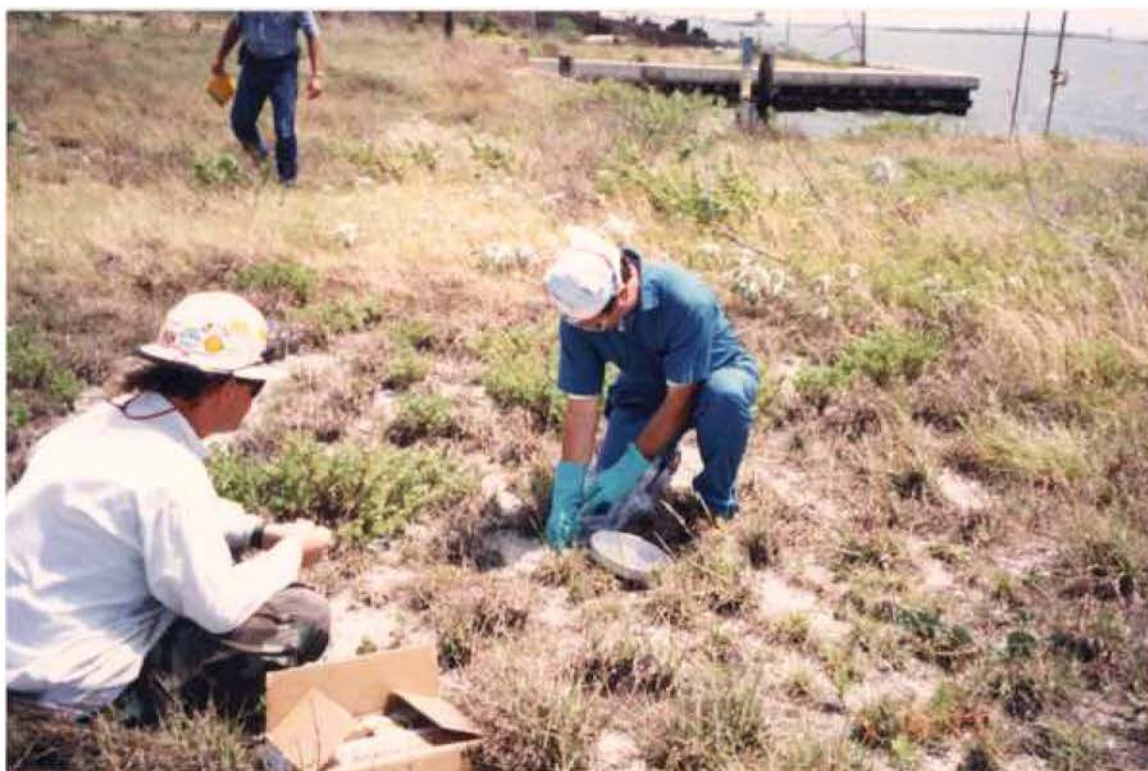
Roll #3 Photo 1 - 5/18/2000 Taken by: M.Cordell. Sampler: W. Newberry. Collection of Sample SO-36 at NORCO dock. Direction: Northeast.

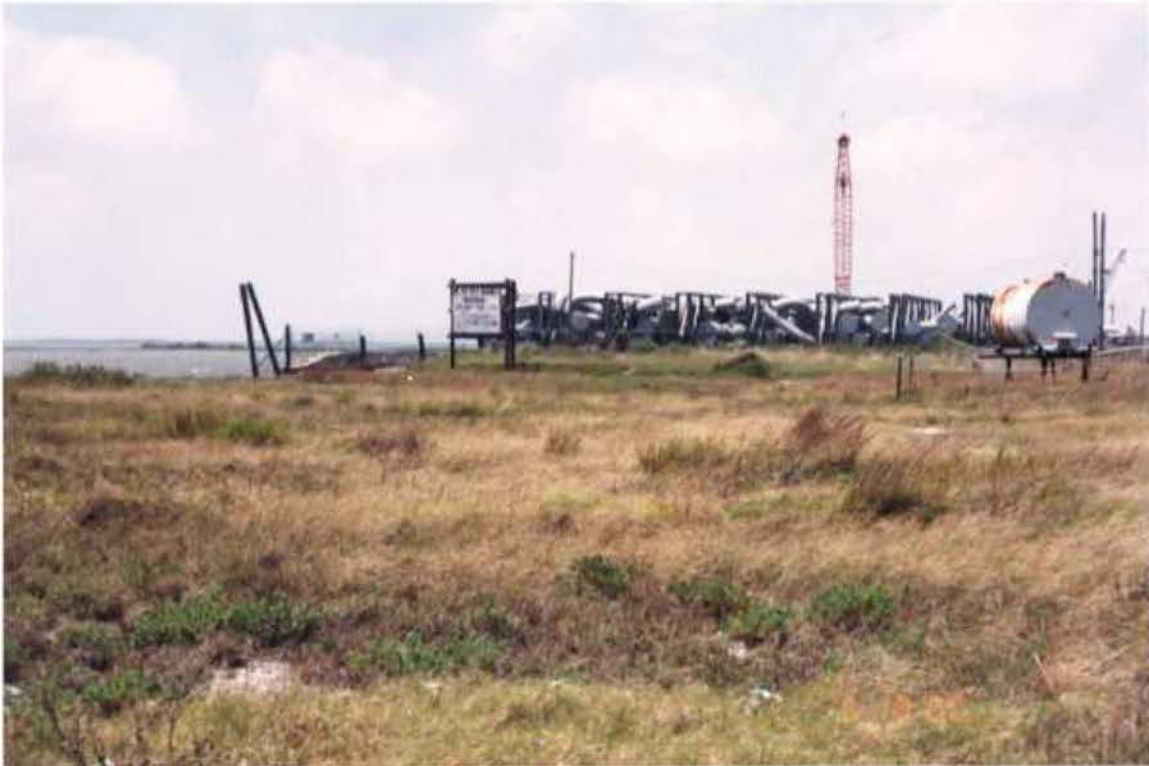
Roll #3 Photo 2 - 5/18/2000 Taken by: M.Cordell. Sampler: W. Newberry. From a location near SO-36, an aboveground storage tank is located on the NORCO property. Drainage appears to flow towards PPE<sub>3</sub> at Redfish Bay (SE-31). Direction: South.
